## Water Intrusion and Premature Coil Failure (E255)

### Coils and Water Don't Mix!

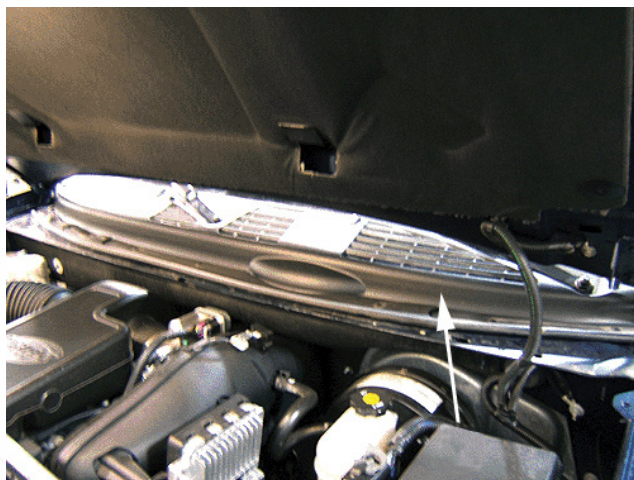
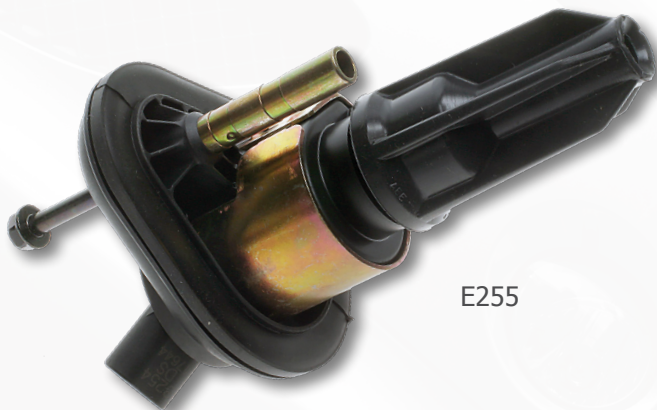
Check for possible DTC codes P0300 through P0306 and inspect the coils and spark plugs. If upon inspection of the coils, a white chalk-like build-up on the inside and/or outside of the spark plug boots is detected, the coils have been damaged and must be replaced—BWD® hi-quality E255 coils should be installed. It is also advised that the spark plugs be replaced.

Water can seep past the engine cam cover and collect below the coils in the spark plug wells of the cylinder head resulting in a possible misfire. To prevent this condition from reoccurring, the AIP seal must be replaced with a replacement seal that redirects the water away from the engine cam cover.
