Just the Facts

Water Intrusion and Premature Coil Failure (E255)

Coils and Water Don't Mix!

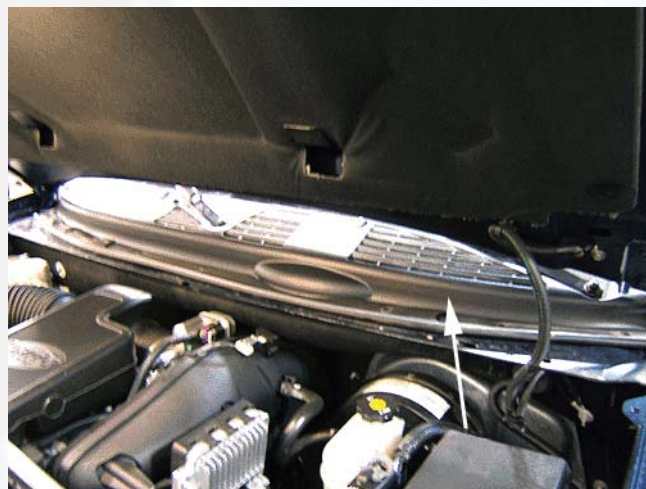
Check for possible DTC codes P0300 through P0306 and inspect the coils and spark plugs. If upon inspection of the coils, a white chalk-like build-up on the inside and/or outside of the spark plug boots is detected, the coils have been damaged and must be replaced—BWD hi-quality E255 coils should be installed. It is also advised that the spark plugs be replaced.

Water can seep past the engine cam cover and collect below the coils in the spark plug wells of the cylinder head resulting in a possible misfire. To prevent this condition from reoccurring, the AIP seal must be replaced with a replacement seal that redirects the water away from the engine cam cover.
