## Don't Get PO'ed with PO401 Codes

## Ford P0401 Issues

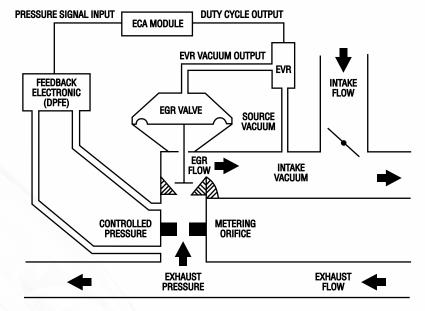
System Diagram

The other parts that commonly get overlooked are the EGR Valve Regulator (EVR), which is cataloged as an EGR control solenoid, the DPFE hoses, and carbon build-up inside the EGR system. The EVR is responsible for supplying the proper vacuum to the EGR valve. Any resistance in this control circuit or failure of the EVR can cause a P0401 code. The original DPFE hoses are a special high-temperature hose. These hoses can crack or collapse internally over time due to intense thermal cycling that takes place within the EGR system.

To prevent a reoccurrence of the P0401 code, BWD® recommends inspecting and replacing if necessary, the EVR and DPFE hoses when replacing the DPFE sensor. To further guard against a P0401 code, a decarbonization treatment of the EGR system should be performed.
