## Don't Get PO'ed with PO401 Codes

## Ford P0401 Issues

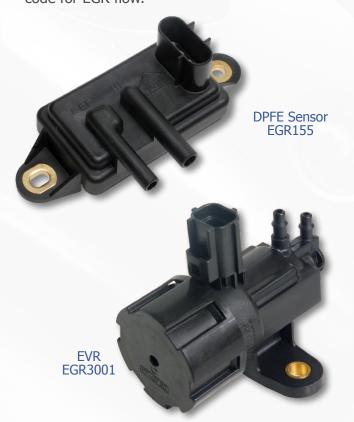
The most common issue is the failure of the EGR Pressure Feedback sensor commonly known as the DPFE sensor. If the diaphragm in the sensor becomes weak or the sensor is contaminated with moisture it can fail to supply the computer with the correct reference voltage. When this occurs, the computer increases the vacuum supply to the EGR valve causing the vehicle to run poorly. When the low flow signal is unable to be corrected by the computer's adjustment, then the computer sets a P0401 code for EGR flow.

To prevent a reoccurrence of the P0401 code, BWD® recommends inspecting and replacing if necessary, the EVR and DPFE hoses when replacing the DPFE sensor. To further guard against a P0401 code, a decarbonization treatment of the EGR system should be performed.
