TechSmart® High Pressure Fuel Pump Cam Follower

TechSmart® now offers a high-quality direct replacement High Pressure Fuel Pump Cam Follower for 2013-2006 VW/Audi 2.0T.

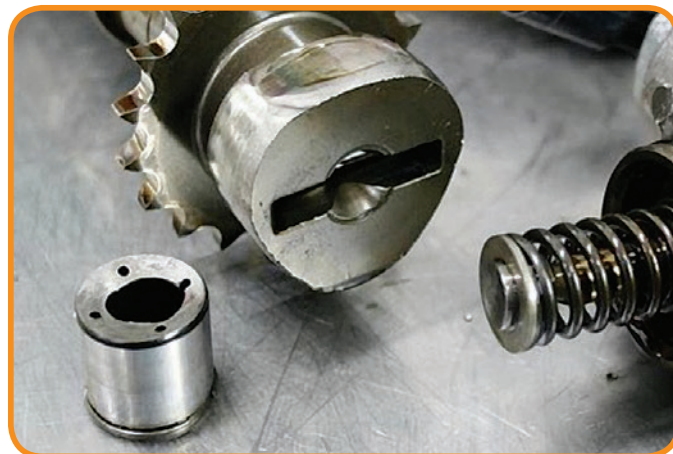
The low-friction coating on the original units can wear down over time causing excess friction against the cam lobe and high-pressure fuel pump plunger. This can lead to extreme engine damage and an expensive repair. Checking and replacing the cam follower with the TechSmart® T48001 will save money in the long run.

Catastrophic Failure

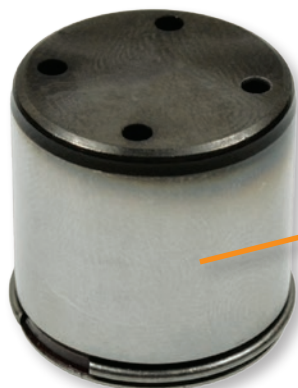
New
TechSmart®
T48001
